AFAPL-TR-69-35  
Volume III

ADVANCED TURBINE ENGINE GAS GENERATOR  
CONCEPTUAL STUDIES AND FEASIBILITY  
EXPERIMENTAL TEST PROGRAM  
(UNCLASSIFIED TITLE)

Volume III: Materials Section (Table LXXV)

Frederick G. Groh  
Pratt & Whitney Aircraft Division  
United Aircraft Corporation

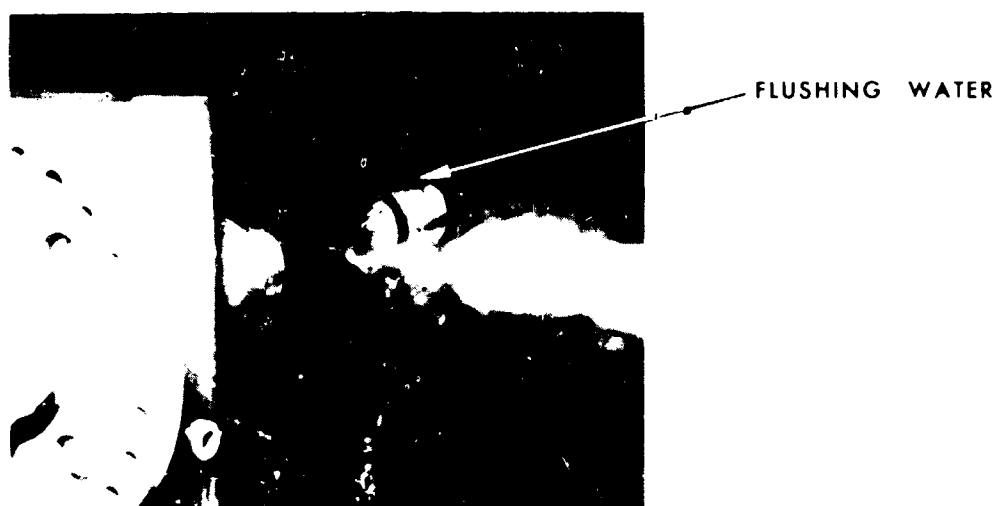
STREAM WITH POWER OFF

STREAM WITH POWER ON

Figure 10 Closeup View of Push-Pull Low-Cycle Fatigue Specimen Being Drilled by ECID Process

(U) The ECID (electrochemical impingement drilling) process is a special application of the electrochemical machining process. In the ECM process, the cathode tube carrying the electrolyte moves through the work piece, and, therefore, the smallest hole that can be produced is limited by the outside diameter of the cathode tube. In the ECID process, this limitation is eliminated by releasing the electrolyte through a jet across a gap of 0.020 to 0.100 inch. The jet is produced by pumping the electrolyte into the nozzle at high pressure. A direct-current power supply is placed across the electrolyte and the work piece, which deplates material from the work piece. A schematic diagram of the equipment used for the process is shown in Figure 7. Figure 8 shows the appearance of the equipment at the start of the program, and Figure 9 shows the appearance of the equipment after modifications were made to permit three-dimensional positioning of the nozzle. A closeup view of a typical specimen being drilled is shown in Figure 10.

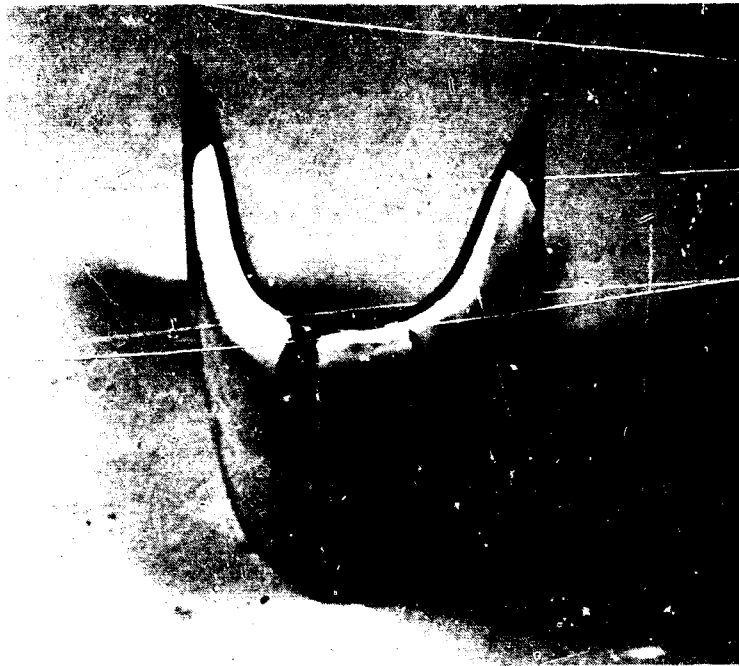
Figure 34 Typical Specimen After Bending to Evaluate Bond Strength  
Between Abradable Material and Backing Plate XP-78405

(U) The bond strengths obtained between the nonmetallic and metallic materials and the backing plates were initially evaluated by bend testing. A typical bend specimen is shown in Figure 34 after testing. Final evaluation of the bond strengths were made during the static oxidation and aging tests and during the dynamic abrasion tests. Bonds were considered to be satisfactory only when all failures of the material occurred outside of the interface between the specimen and the backing plate.

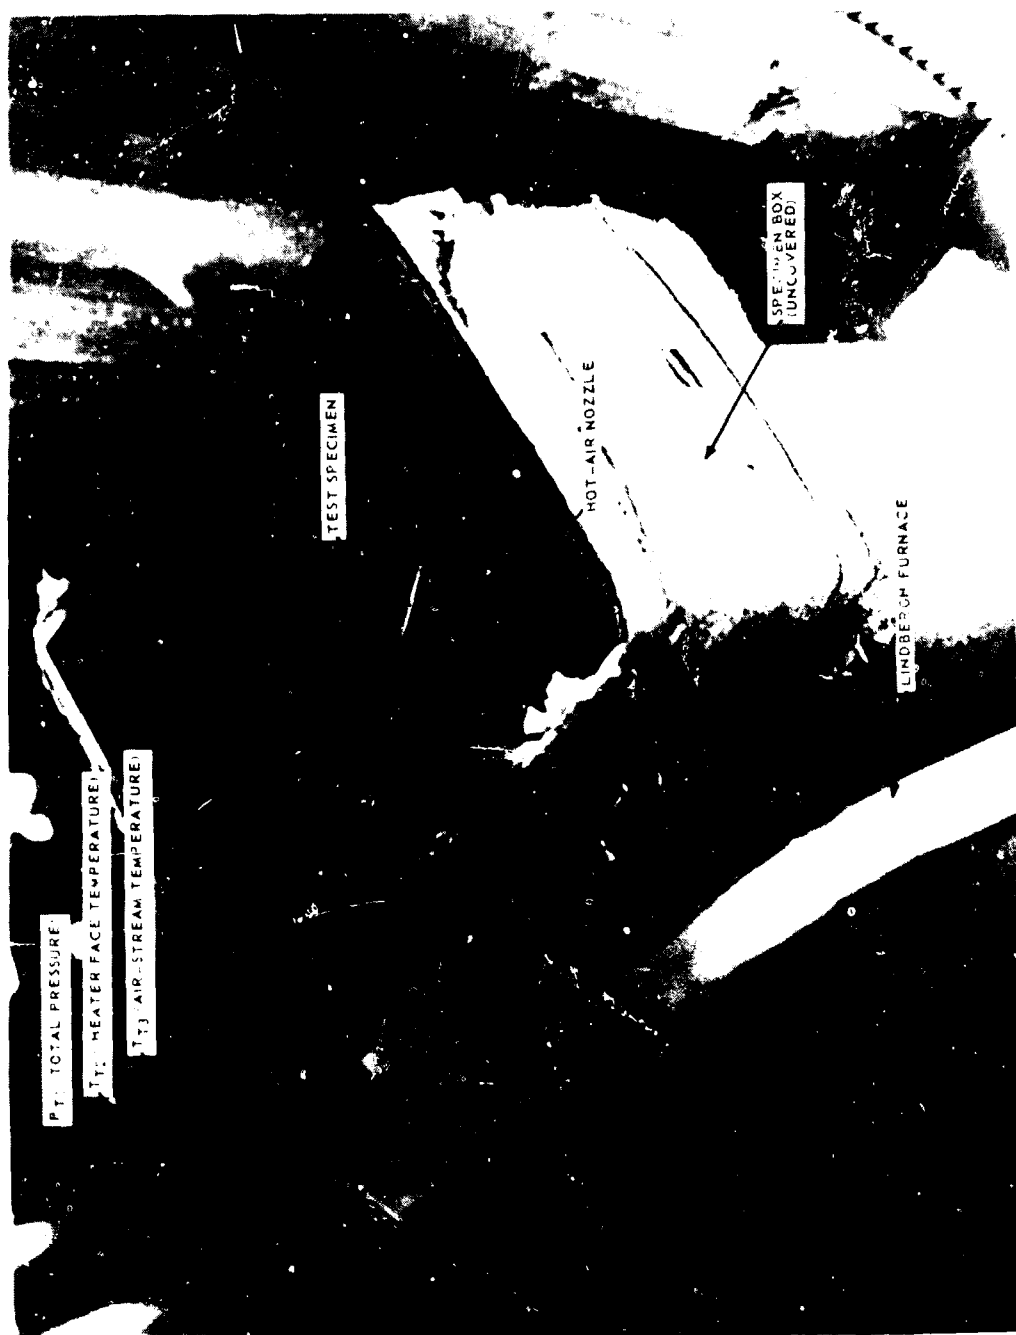
Figure 47 Hot Gas Erosion Test Equipment for Abradable Materials for  
Medium-Temperature Use  
N025057

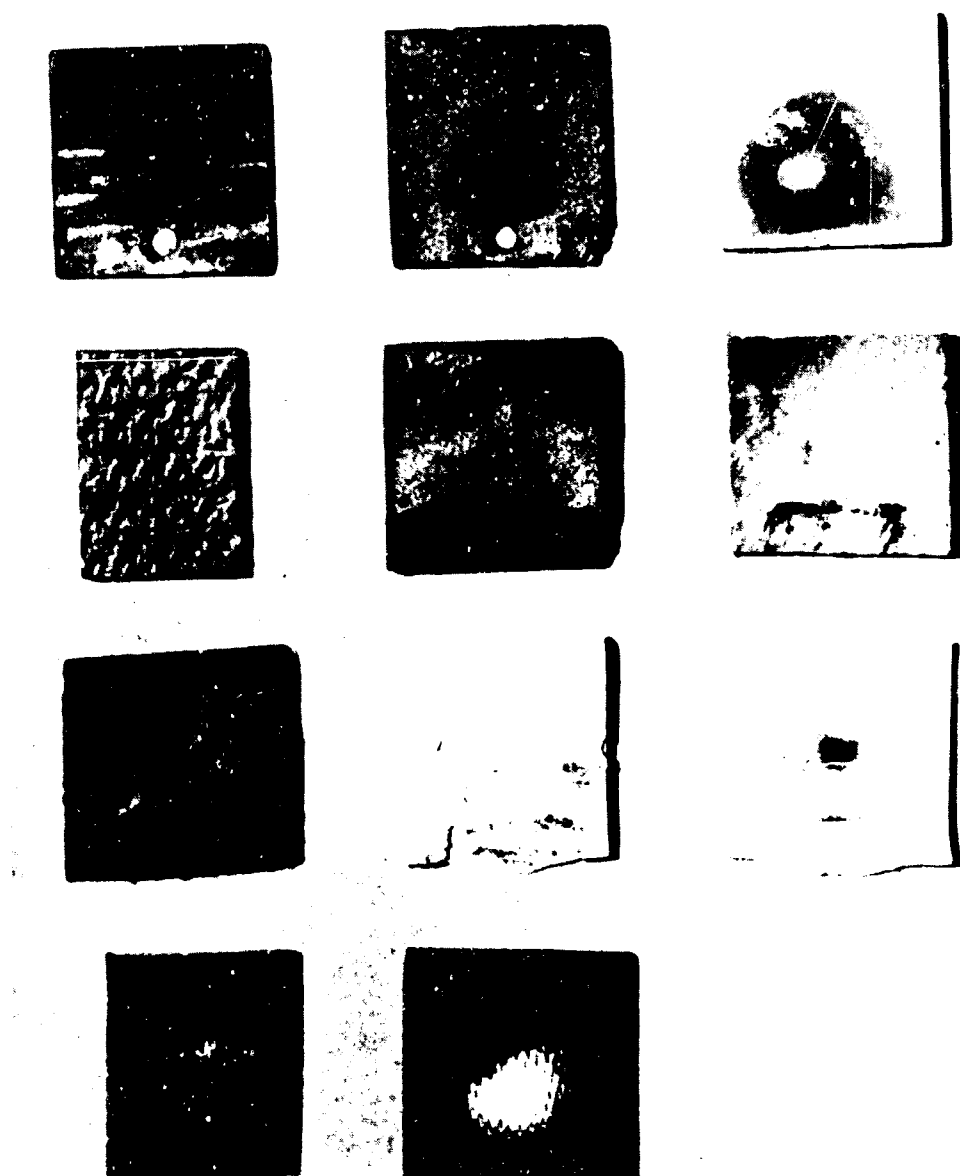
Figure 50 Hot Gas Erosion Specimens After Testing

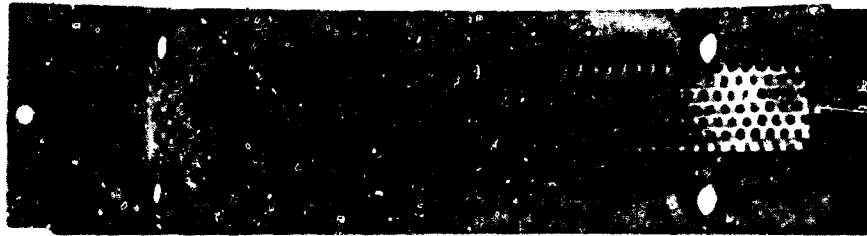
Figure 73 Type 410 Stainless Steel Drilled Honeycomb Aged Rub-Strip  
Specimen After Dynamic Abrasion Testing at 1145°F XP-77927

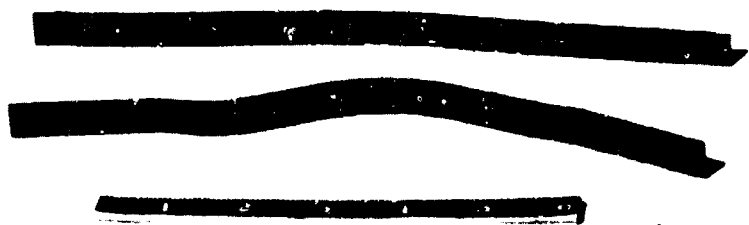
Figure 89 Normal Low-Cycle Fatigue Specimen After Failure (Top) and Hinged Specimen (Bottom)
